Inspection Report

**Property Address:
777 Pleasant Drive
Bartlett Il**

Date: 9/7/2008	Time: 04:00 PM	Report ID: 08-sample
Property: 777 Pleasant Drive Bartlett Il	Customer: Mrs. Rose Goody Mr. Ross Goody	Real Estate Professional: Shawana Liotine Realty Executive Premiere

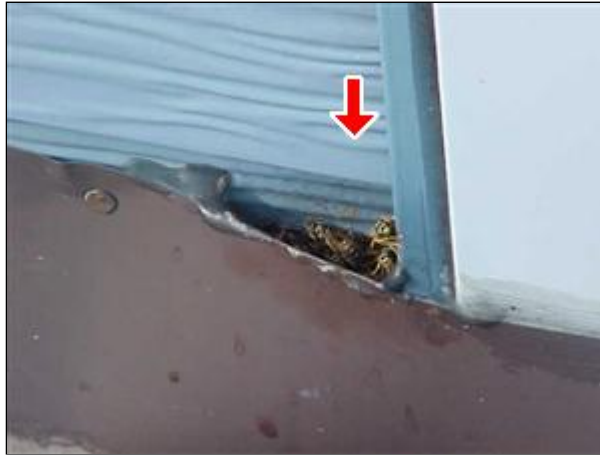
1.1 Picture 1

1.1 The flashing on the fireplace chimney is open at the top and there is a wasp nest inside. This should be repaired, caulked and the wasp exterminated. The exterminating should be done by a professional because of the location and the danger of falling from the roof. The flashing should then be removed to see if there has been any damage to the sheathing or the framing of the chimney. This should be done by a licensed roofer.

The flashing on the fireplace chimney is open at the top and there is a wasp nest inside. This should be repaired, caulked and the wasp exterminated. The exterminating should be done by a professional because of the location and the danger of falling from the roof. The flashing should then be removed to see if there has been any damage to the sheathing or the framing of the chimney. This should be done by a licensed roofer.

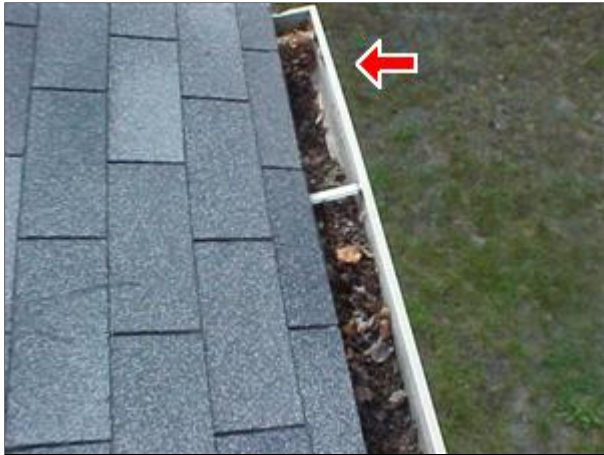
1.4 Picture 1

1.4 The gutters seem to be intact but are filled with debris and need a good cleaning, though it rained the day before it was not raining the day of the inspection and I could not tell if they were draining properly with all the debris.

The downspouts are turned out with an elbow and they have splash blocks, but because of the pitch of the land these should have extensions added on and some of them turned to flow the water away from the house.

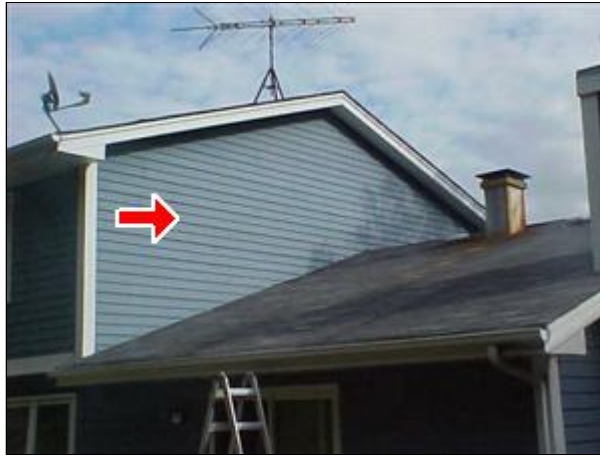
2.0 Picture 1

2.0 The siding on second floor wall and gable on the garage side is loose and could be blown off during a strong wind. The siding under the east window on the front of the house is also loose and well as the bottom row on the rear of the house. The remainder of the siding was not inspected because I could not reach it with out setting a ladder against it and I did not want dent it or cause any more damage to it. The siding needs to be checked out further and needs to be repaired or replaced. This need to be done by a licensed siding contractor.

The siding on second floor wall and gable on the garage side is loose and could be blown off during a strong wind. The siding under the east window on the front of the house is also loose and well as the bottom row on the rear of the house. The remainder of the siding was not inspected because I could not reach it without setting a ladder against it and I did not want to dent it or cause any more damage to it. The siding needs to be checked out further and needs to be repaired or replaced. This needs to be done by a licensed siding contractor.

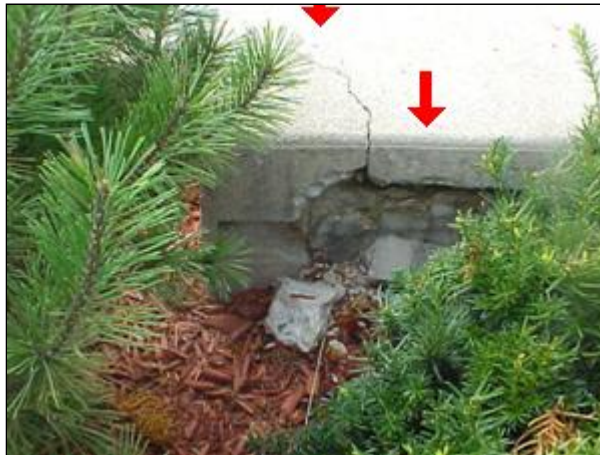
2.3 Picture 1

2.3 The front stoop is has cracks on both corners and the right corner is showing deterioration with sections of the concrete missing. This should be repair as to keep it from deteriorating further and falling off.

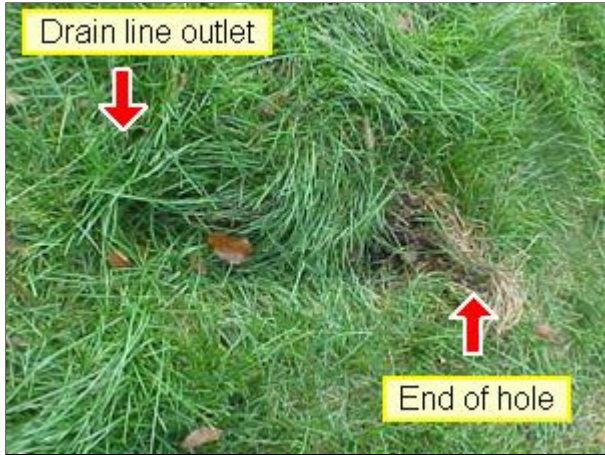
2.4 Picture 1

2.4 Some of the planting should be cut back away from the siding to keep moisture off the building. The contour of the land has the water coming down the hill toward the house, I could not see any drain tile or drainage system to keep the water during a heavy rain from flushing against the house. This could cause some water leakage in the basement.

There is a drainage tube where the front east downspout connects to that comes out on the flat section of the front yard, this may also be connected to the sump pump line. The hole in front of the drain line could cause some to fall or injure themselves. This should be extended to empty out on the slop of the yard.

The driveway is asphalt and has some cracks that should be repaired and seal coated. There are some area at the end of the driveway and the public walkway that should be replaced. The apron, the section between the street and the public walkway is in bad shape and should be replaced. The repairs and the replacement should be done by a licensed asphalt contractor.

The public walkway has two slabs that have hole in them and one of them has dropped about 1" to 1 1/2". This should be replaced. I would check first with the city about who can do the replacement of these slabs.

The rear stoop needs to be caulked with a concrete approved caulking to keep water from entering the joints and freezing expanding the openings.

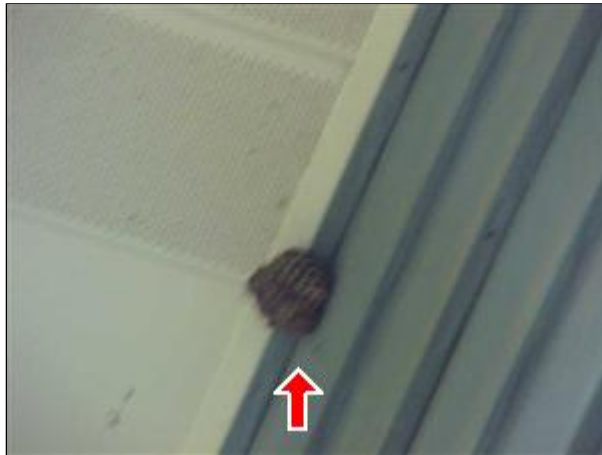
2.5 Picture 1

2.5 There are wasp nest on the under side of the overhangs that should be removed. The venting sections of the overhangs need to be checked to be sure there is an opening in the overhangs for air flow. See the notes under the ventilation section.

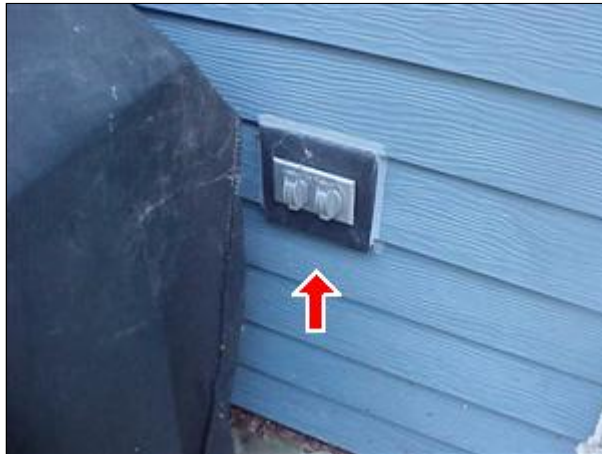
2.7 Picture 1

2.7 The exterior outlet at the front of home and rear of home is a "three-prong" receptacle, and is not a "three-prong" GFCI outlet with exterior cover. This is a safety issue that needs to be corrected. A qualified licensed electrician should perform repairs that involve wiring.

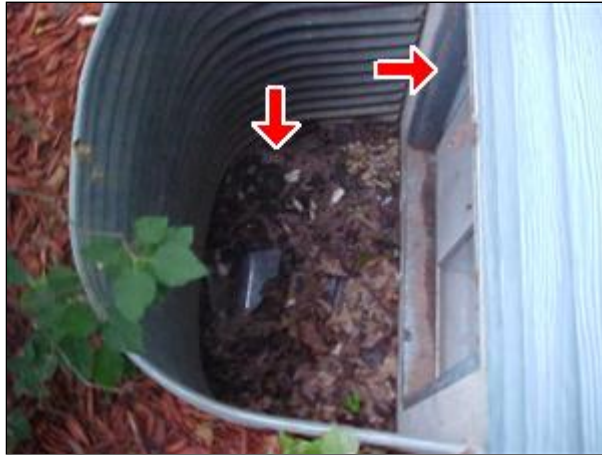
2.8 Picture 1

2.8 The window wells need to be cleaned out to make sure the drains are clear and free from debris to allow water to flow freely. Also the large escape window is missing the cover and someone could fall in injuring themselves, a new cover should be installed. The escape window itself does not lock properly and can be opened from the exterior allowing entry by anyone, this should be repaired so it will lock properly and open with ease.

The window wells need to be cleaned out to make sure the drains are clear and free from debris to allow water to flow freely. Also the large escape window is missing the cover and someone could fall in injuring themselves, a new cover should be installed. The escape window itself does not lock properly and can be opened from the exterior allowing entry by anyone, this should be repaired so it will lock properly and open with ease.
